Manhole Inspection Summary

Manhole # S19I__040MH

Insp Date: **2/29/08 11:01 AM**

Location Address: **8 s smallwood st**

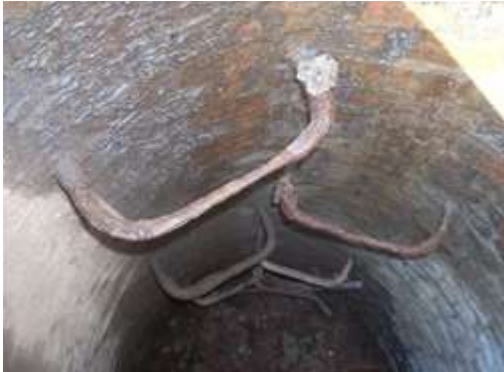
Defect 1

Count: **6** Missing: **0** ☒ **Corroded**

corroded steps

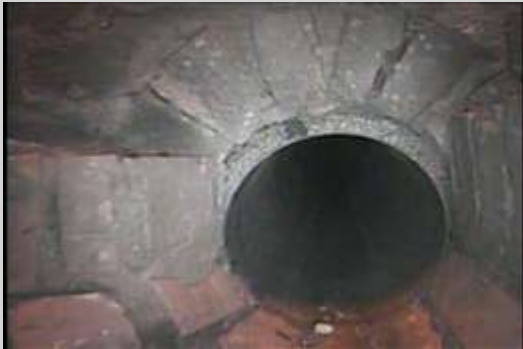
12 O'Clock Outflow

Pipe Height: **8.4** (in.) Rod and Bar (Angled)
Pipe Material: **Clay** ☐ Pipe Lined
Invert Depth: **10.13** (ft.) Flow Characteristics: **Slow**
Deposits: ☒ None ☐ Mud ☐ Sludge ☐ Debris ☐ Grease
Silt Depth: **0** (in.) Deposits Extent:
Infiltration: **None** Pipe Seal Cond: **Sound**

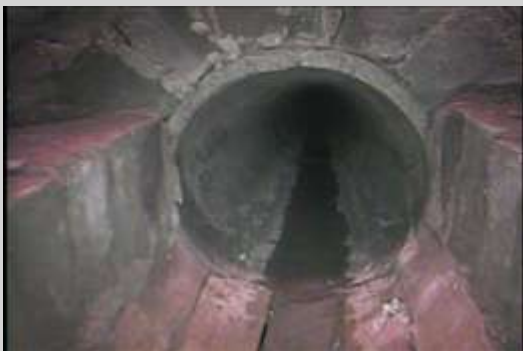
6 O'Clock Inflow

Pipe Height: **8.4** (in.) Rod and Bar (Angled)
Pipe Material: **Clay** ☐ Pipe Lined
Invert Depth: **9.57** (ft.) Flow Characteristics: **Slow**
Deposits: ☒ None ☐ Mud ☐ Sludge ☐ Debris ☐ Grease
Silt Depth: **0** (in.) Deposits Extent:
Infiltration: **None** Pipe Seal Cond: **Sound**

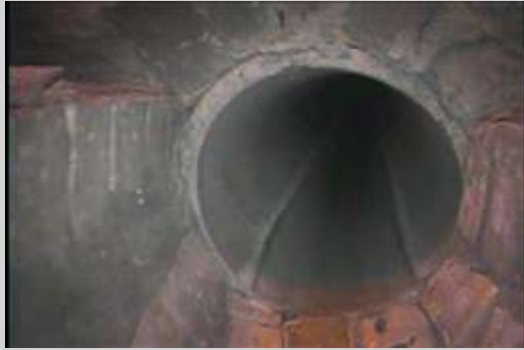
9 O'Clock Inflow

Pipe Height: **8.4** (in.) Rod and Bar (Angled)

Infiltration: **None** Pipe Seal Cond: **Sound**
